Instituto Politécnico de Setúbal

Mestrado em Segurança e Higiene no Trabalho Projecto Final

Melhoria na Segurança e Higiene no Trabalho Após a Certificação Numa Multinacional

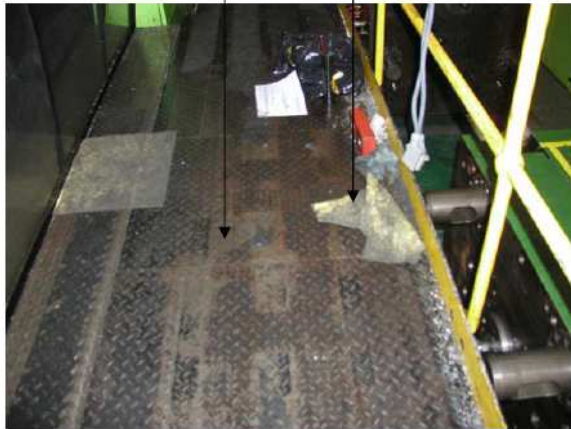
<p>Date: 06/03/2007 Time: 0740</p> <p>Description of Work Performed:</p> <p>The setter was changing over the mould tool on machine 2.</p> <p>Description of Incident:</p> <p>The setter was exiting the access platform when he slipped down the stairs and fell onto his lower back.</p> <p>The setter was holding on to the handrail during his descent.</p> <p>He was treated by the first aider and then walked to see the Plant Doctor in the Occupational Health Department. He was taken to hospital and then sent home.</p> <p>The stairs were examined and found to be contaminated with oil with patches where the non-slip coating had worn.</p> <p>The employees' footwear was found to be contaminated with oil and dirt.</p> <p>Injuries: Contusion (bruise) to lower back</p>	<p>Photo: Shows worn non slip surface patches and residual oil contaminated pads on IMM2 access platform.</p>

<p><u>Key Point Summary</u></p> <ul style="list-style-type: none"> ➤ The cleaning regime for the access platforms needs to be controlled more effectively ➤ Employees need to report oil spills quicker ➤ Leaking machines need to be examined and leaks prevented to reduce walkway contamination- 	<p><u>Key Learning Points</u></p> <ul style="list-style-type: none"> ➤ The moulding machines need to be examined for oil leaks with remedial actions, that do not involve the use of oil absorbance, employed. ➤ Consideration needs to be given to the potential for oil contamination when siting machinery

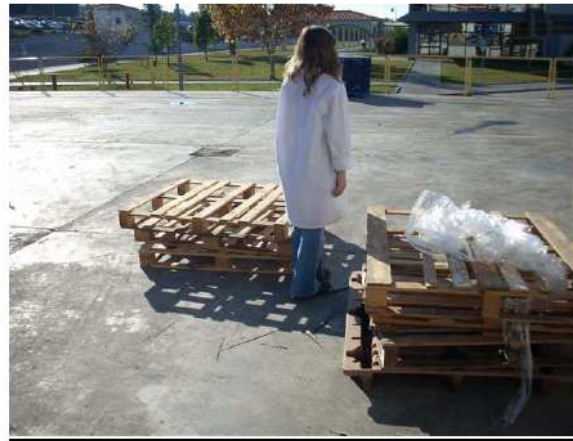
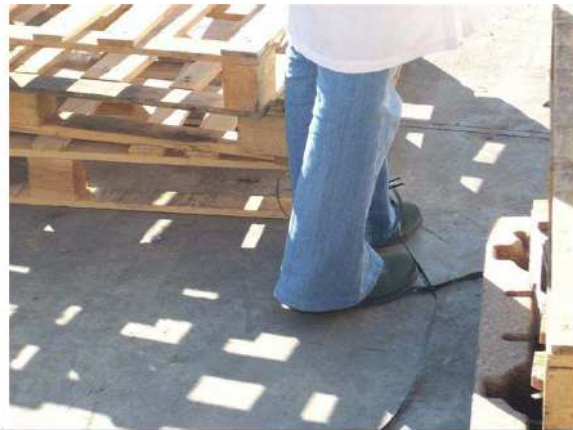
Photo:

An employee from the quality area in the Compressors plant came to Electronics plant to collect signatures for RFS documents. When she was returning to the Compressors building, instead of using the pedestrian passage, went through an area with pallets (area to collect waste pallets) and tripped in a plastic strap. She lost the balance and fall down causing a fracture in the arm.

Injuries:
Arm fracture.

- Reinforce the pedestrian passage rules.
- Reinforce the need to have attention at all time.
- Take disciplinary action when the safety rules are not followed.

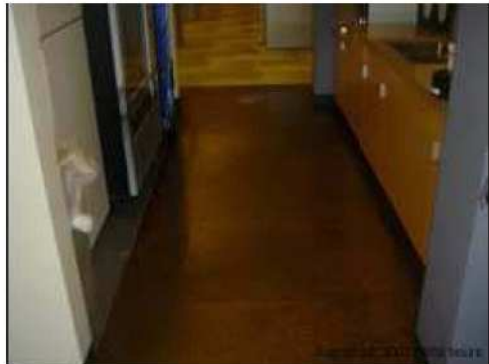
<p>Date and Time of Injury: August 24, 2007 4:30 p.m.</p> <p>Problem Description Employee slipped on wet floor which did not have the proper warning signs. In addition the cleaning staff was mopping the floors during working hours instead of during the off shift. Upon investigation it was determined that this situation had occurred previously and Security and/or Facilities were not notified.</p> <p>Interim Corrective Action Cleaning Contractor reviewed the importance of using the wet floor signs and not mopping the floors during working hours at the facility</p> <p>Root Cause Failure to follow the procedure which required the posting of warning signs when cleaning staff washes floors.</p> <p>Permanent Corrective Action Cleaning Contractor has been instructed to not mop any floors before 5:30 p.m. Use of floor wet signage is imperative. Failure to comply will result in an employee disciplinary write up and entire staff re-training. The entire staff re-training is to dissuade non-compliance because their failure will affect the entire staff. Hopefully, fellow employees will consult fellow employees who do not comply because they do not want to sit through the re-training. A communication will re-enforce the importance of reporting unsafe conditions to Visteon Village Security</p>	<p>Photo: At time of Accident (Wet Floor without warning Sign)</p>

<p><u>Key Point Summary</u></p> <ul style="list-style-type: none"> ☞ Floors were mopped depositing a thin film of water ☞ Signs were not posted to warn of the slip potential ☞ An employee walked on the floor and slipped ☞ The employee fell and suffered a shoulder fracture 	<p><u>Key Learning Points</u></p> <ul style="list-style-type: none"> ☞ Always post warning signs when floors are wet ☞ Do not wash floors during normal working hours ☞ Other employees had seen this situation in the past and not notified the security or facilities

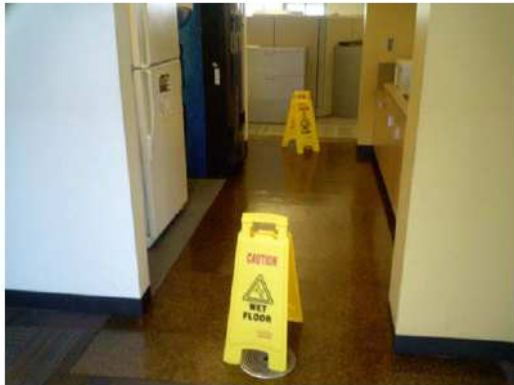
<p>Correct situation (Warning signs in place)</p>

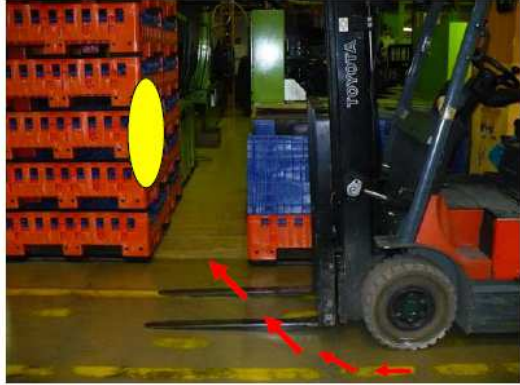
<p>Forklift standing position - not permanently</p> <ul style="list-style-type: none"> 🟡 - hit position as a result of operator falling (left arm) ➡ - direction of operator's walk

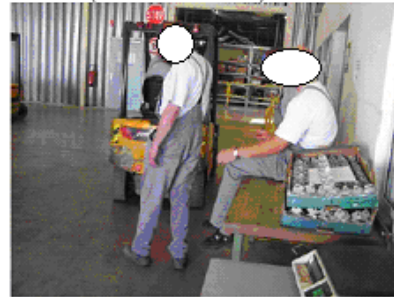
Photo 1: accident/incident

Before accident (accident simulation)

- ⊖ Drivers must pay appropriate care and attention to the operation of the HILO

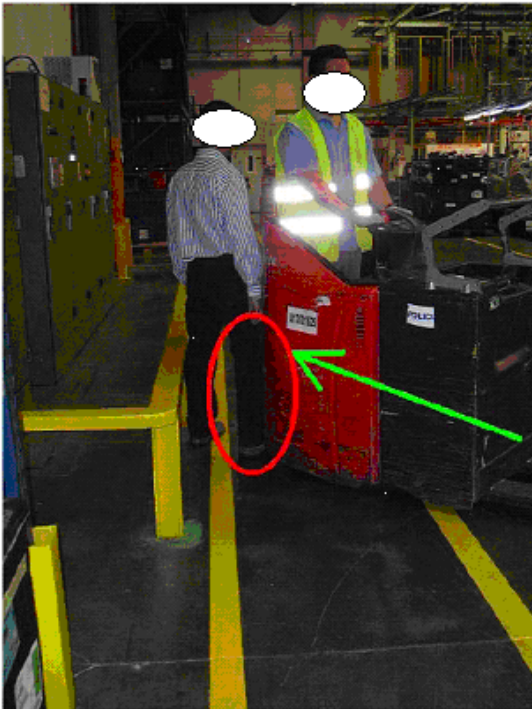
<p><u>Date & Time of Injury:</u> LTC-14-05-08 00:40 am</p> <p><u>Incident Description:</u></p> <p>The driver of electric pallet mover, approached to talk with an operator who was walking in the pedestrian walkway. By mistake, the driver lean on his arm in the machine and it starts to reverse backwards, the operator leg resulted caught against the barrier.</p> <p><u>Additional information:</u></p> <ul style="list-style-type: none"> o Witness: Yes o Injury Type: contusion o Affected Body Part: Leg o Estimated lost days: 15 <p><u>Root Cause</u></p> <p>Flag: Security: Unsafe action to the driver that invades the pedestrian walkway</p> <p><u>Interim Corrective Action:</u></p> <ul style="list-style-type: none"> - Prohibition approaching pedestrians when driving a vehicle - Review hazards advertising in the area - Cancel the machine driver permit + consider further disciplinary actions <p><u>Permanent Corrective Action:</u></p> <ul style="list-style-type: none"> - To install protective barriers at the pedestrian crossing & corridors, where possible - Safety walks controls: check unsafe acts (operators do not remain and talk with others in pedestrian walkways) - Safety Talk forklift drivers & pedestrians. 	<p><u>Photos:</u> accident / incident</p>

<p><u>Relevant EH&S Standard</u></p> <ul style="list-style-type: none"> o <u>Standard:</u> VCS-2 Pedestrian and vehicles Safety o <u>Failure Standard (Y/N):</u> N o <u>Violation of safety(Y/N):</u> unsafe action 	<p><u>Key Learning Points</u></p> <ul style="list-style-type: none"> o Drivers must pay appropriate care and attention, and don't approach to pedestrians with the vehicle. o Operators mustn't stand or talk in the walkways on traffic areas, or on other risky areas..

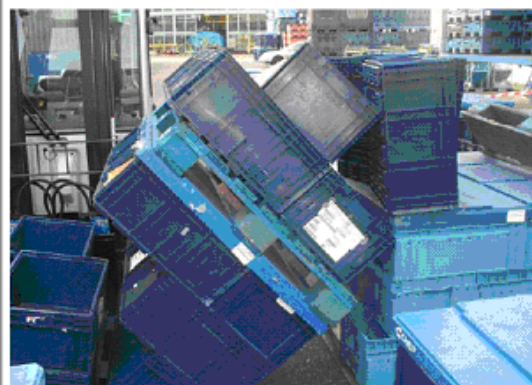
Photo 1: Boxes tipping off pallet

-The operative was bending down pulling a packing strap up ready to bind a pallet of KLT's in row 1. The FLT driver placed a stack of pallets and KLT's 3 high in row three. The base of the pallet was damaged causing the pallets to topple over with the upper pallet falling down and striking the operator on his head

- 1) Pallets were received from supplier in poor condition.
- 2) Employee was working close to a forklift while it was moving a high load (3 high KLT pallets).

EHS Manager – ☐ to liaise with Buyer and tell Chep we will not accept goods on damaged pallets

- Transport materials need to be examined for wear and tear when accepting delivery
- Transport companies need to be reminded on the need to inspect and segregate damaged transport materials
- Employees should not work in close proximity to forklifts moving high loads.

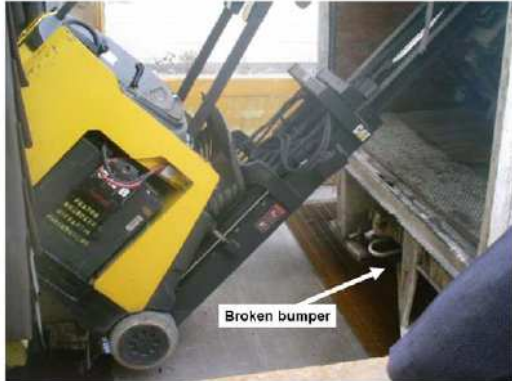
<p><u>Date & Time of Incident:</u> March 5, 2009</p> <p><u>Incident Description:</u></p> <ul style="list-style-type: none"> - Driver moved trailer with red light being activated on outside of the dock. Driver accepted that he did not check if red light was activated, because he had received communication from Hi-Lo driver that load had been completed. Hi-Lo driver explained that he told trucker load was complete. Hi-Lo driver then was told to load two more containers, but activated the green light to red (outside). Minutes later, the driver comes to dock in order to remove trailer from dock without reviewing the visual confirmation of the dock light. - It is important to note that the trailer bumper before the incident was defective. The bumper would not make good contact with hook, because bumper was damaged. NO MECHANICAL ISSUES IN OUR DOCK. - The Hi-Lo didn't touch the ground but a 45 grades inclination was the final position. - No injuries. A revision to the dock and Hi-Lo were performed. - Diver will be penalized when we analyze all his history and accomplish with our procedures. <p><u>Additional information:</u></p> <p>Witness (Y/N): - yes</p> <p>Supervisor informed yes when? – March 5, 2009</p> <p>Has this occurred before? (Y/N) – No</p> <p><u>Safety Incident Information:</u></p> <p>Injury Type: - NO</p> <p>Affected Body Part: - NO</p> <p>Estimated lost days: - NO</p> <p>Repetitive disorder (Y/N) - NO</p> <p><u>Root Cause</u></p> <p>Flag (highlight one) : PROCEDURES WASN'T ACCOMPLISHED AT 100%</p> <p><u>Interim Corrective Action:</u></p> <ul style="list-style-type: none"> - Supplier received the direction to review all their trucks and trailers boxes to ensure that their equipment meets safety standards. - Driver will be disciplined. - Hi-Lo drivers re-enforcement of procedures (at all Coclisla plants) - Checked all the docks in all the plants but we will do it again to assure 100% conditions. <p><u>Permanent Corrective Action:</u></p> <p>Contractor received the advice to review all their trucks and trailers boxes to assure excellent conditions to us to prevent this issue.</p>	<p><u>Photos:</u></p>

<p><u>Relevant EH&S Standard</u></p> <ul style="list-style-type: none"> ➤ <u>Standard:</u> - Hi-Lo Procedure ➤ <u>Gap to Standard (Y/N):</u> - Yes ➤ <u>Safety Violation (Y/N):</u> - Yes, the truck driver left dock when the red light was on (signalling that the trailer should not be removed from the dock) 	<p><u>Key Learning Points</u></p> <ul style="list-style-type: none"> ➤ Contractors have to be constantly supervised ➤ Safety reviews of Trailers, Docks, and Hi-Lo are important. ➤ All trailers should be inspected prior to backing into the dock to assure that the ICB Bar (bumper to which the dock lock attaches) is intact. If the ICB Bar is not intact special procedures to offload should be followed to assure that the trailer cannot depart ➤ Clear communications between the truck driver and the Hi-Lo driver are critical.

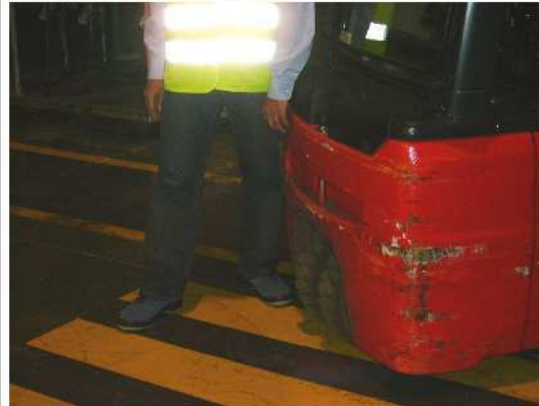
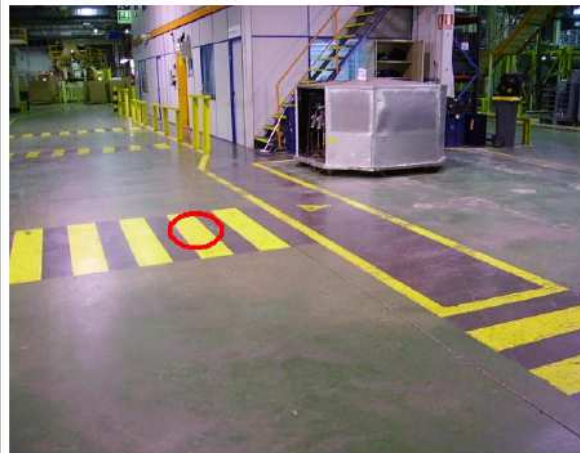
Photos: accident / incident

- A fork lift driver was transporting a rack driving backwards, coming from a curve. The truck hit an operator on the pedestrian crossing. His lower leg was broken in two points. Ambulance took him to hospital.
- The truck was in perfect conditions, acoustic signal was on, driver had the proper accreditation and training (last time in nov-07)

Driver unsafe action.

- Drivers must pay appropriate care and attention, very especially at pedestrian crossings and corridors
- Review and deliver pedestrian traffic rules
- Avoid pedestrian crossings too close to curves

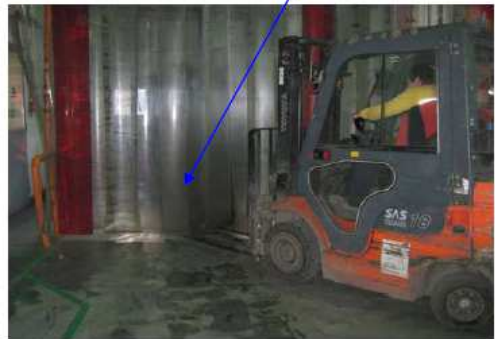
<p>crash place</p> <p>A - The Hi-Lo Driver goes into product.hall B - The Hi-lo Driver goes out from product.hall - both through the flying plastic curtain (belts)</p> <p>Photo 2 : place of incident / work environment or corrective action</p>

<p>soiled plastic curtain (several plastic belts in a line)</p>

<p><u>Relevant EH&S Standard</u></p> <p>☞ <u>Standard :</u> - Traffic Rules ☞ <u>Gap to Standard (Y/N)</u> - N ☞ <u>Safety Violation (Y/N)</u> - Y</p>	<p><u>Key Learning Points</u></p> <p>☞ - Permanent observance of all safety rules for Forklift Drivers . ☞ Revision of all suspicious and danger places with curtains to prevent next possible incident ☞ Regular reassessment of risk analysis</p>

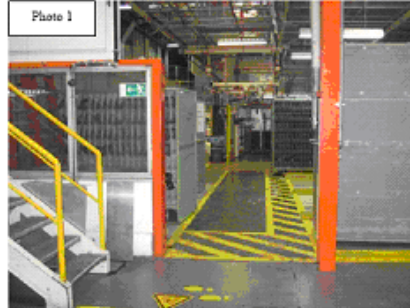
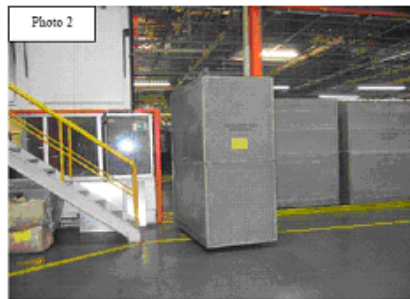
Photo:

Laceration at back of the hand

- ☞ - The reason for this accident is the inattention of the worker.
- ☞

- ☞ - Instruction by supervisor again!
- ☞ - Attach of guidances in the area of pylons

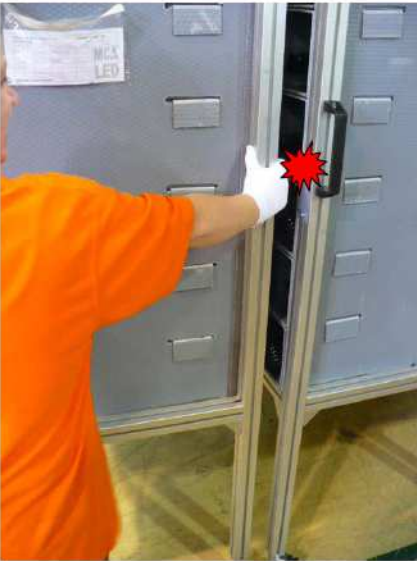
<p>Illustrational photo</p>

<p><u>Date & Time of Injury:</u> 08/27/2008 11 am</p> <p><u>Incident Description:</u></p> <p>The operator was pushing full container to next production process. During manual handling this operator crashed into neighbouring container. It caused a contusion of the left wrist.</p> <p><u>Additional information:</u></p> <ul style="list-style-type: none"> ➤ <i>witness (Y/N):</i> - Y ➤ <i>supervisor informed, when:</i> - 08/27/2008 ➤ <i>Flag: first time or repetitive disorder:</i> ➤ <i>Injury Type:</i> - contusion ➤ <i>Affected Body Part:</i> - left wrist ➤ <i>Estimated lost days:</i> - 7 <p><u>Root Cause</u></p> <p><i>Flag: Environmental / Safety / Ergonomic / Fire / Occup. diseases</i></p> <ul style="list-style-type: none"> - Improper manual handling - Design of holders <p><u>Interim Corrective Action:</u></p> <ul style="list-style-type: none"> - Medical investigation by company physician. <p><u>Permanent Corrective Action:</u></p> <ul style="list-style-type: none"> - New design of container holders - Review of risk assessment 	<p>Photo 1: accident</p>

<p><u>Relevant EH&S Standard</u></p> <ul style="list-style-type: none"> ➤ <u>Standard:</u> - N/A ➤ <u>Gap to Standard (Y/N):</u> - N ➤ <u>Safety Violation (Y/N):</u> - N 	<p><u>Key Learning Points</u></p> <ul style="list-style-type: none"> ➤ The design change of containers – new holders, should be verified and approved by relevant experts including safety engineer. ➤ Pay more attention while performing manual transport .

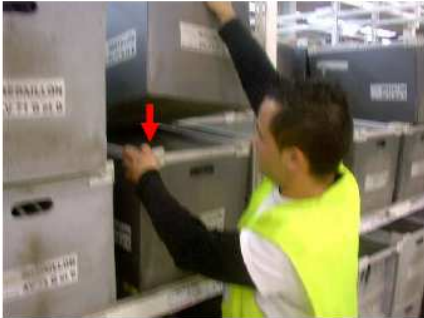
<p>Date:06/11/2007 Time: 11h45 pm</p> <p>Description of Work Performed: The operator was taking some boxes – It is a normal operation.</p> <p>Description of Incident: The operator was taking the upper box. As she lifted the upper box from 20cm, the upper box slipped and felt onto her thumb. The box weights about 5 kgs.</p> <p>It was nothing in appearance very serious. She finished his shift. We believe at this time that it was a first aid.</p> <p>The following day, she came back to the infirmary and said the pain is stronger. She went to the hospital and has a broken finger. She is in plaster.</p> <p>Injuries: left hand, thumb</p> <p>Days off: 6 weeks</p>	<p>Picture:</p>

<p><u>Key Point Summary</u></p> <ul style="list-style-type: none"> ☞ - Behaviour ☞ - Lack of awareness 	<p><u>Key Learning Points</u></p> <ul style="list-style-type: none"> ☞ - Behaviour ☞ - Lack of awareness

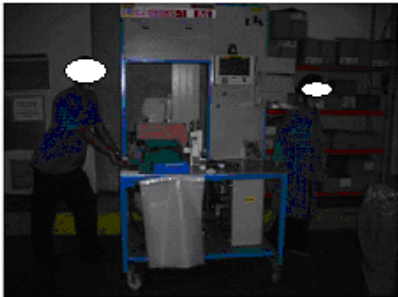
<p>Date: July 18th 2007 Time: 15h45</p> <p>Description of Work Performed: <i>Skilled worker</i></p> <p>Description of Incident: By moving the peripheral equipment of machine 33, and while turning, Mrs R was injured at her ankle.</p> <p>Mrs R was pushing the peripheral equipment while Mr F. was pulling it. The peripheral equipment came on the foot of Mrs R. She had the feet blocked (second picture) and fell on the floor.</p> <p>Injuries: Sprain at the left ankle</p> <p>Estimate date of return: 23rd July 2007 = 2day's loss</p>	<p>Photo:</p>

<p>Mrs R. was pushing the peripheral equipment while Mr F. was pulling it.</p>

<p>The peripheral equipment came on the foot of Mrs. R. She had the feet blocked below and fell on the floor.</p>
<p><u>Key Point Summary</u></p> <p>➡ Keep attention while carrying out the job.</p>	<p><u>Key Learning Points</u></p> <p>➡</p>

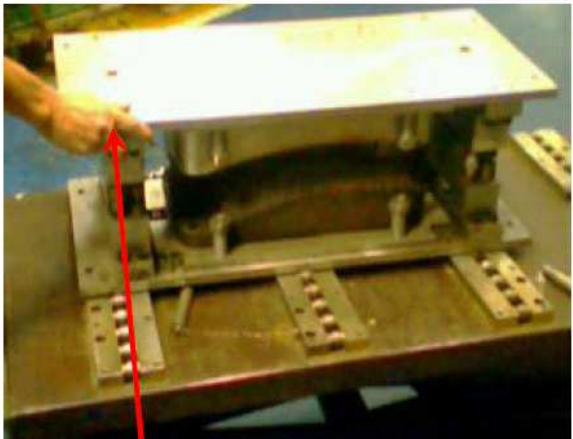
<p>Date: Wednesday, November 14, 2007, 8:50 AM</p> <p>Description of Work Performed: Changeover of CD 345 rear lamp welder.</p> <p>Description of Incident:</p> <p>Employee who works in ASY II accidentally bruised his left during changeover CD 345 rear lamp welder. The employee went to hold up the welder with his left hand while it began to slide off during transportation because the welder was put on the trailer without fastening the location pin. The operator asked leave from November 14th to November 21st</p> <p>Injuries:</p> <p>Bruise to the left hand.</p>	<p>Photos:</p>

<p>Welder strikes employees hand</p>
<p style="text-align: center;"><u>Key Points Summary</u></p> <ul style="list-style-type: none"> ➤ Carelessness used by the employee. ➤ The employee was anxious for the changeover in production. 	<p style="text-align: center;"><u>Key Learning Point</u></p> <ul style="list-style-type: none"> ➤ Discuss working safely with employee, at the same time arrange shift/team leader to audit production equipments periodically and eliminate & improve the potential safety issues. ➤ Require engineer to train all the hot plate operators and make changeover instruction. ➤ Improve the changeover trailer by coloring the pin with red alarm device while at the same time requiring engineering improvement of the pin to the fastening location.

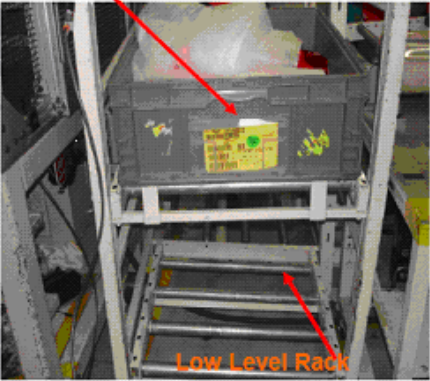
<p><u>Date & Time of Incident:</u> Jul/30/2008; 08:30 am</p> <p><u>DRS Incident number:</u></p> <p><u>Incident Description:</u> The worker was handling a 10 Kg box with both hands in order to locate the box in lower rack section. The container slipped of her left hand, causing a hyperextension in her middle finger.</p> <p><u>Additional information:</u></p> <ul style="list-style-type: none"> ⦿ <i>Witness (Y/N):</i> No ⦿ <i>Contact: By Medical Service</i> 1 1/2 hour after the event. ⦿ <i>Supervisor informed (Y/N), when?</i> Yes, 2 hour after the event. ⦿ <i>Has this occurred before? (Y/N):</i> No <p><u>Safety Incident Information:</u></p> <ul style="list-style-type: none"> ⦿ <i>Injury Type:</i> Sprain ⦿ <i>Affected Body Part:</i> Left hand (middle finger). ⦿ <i>Estimated lost days:</i> 13 days ⦿ <i>Repetitive disorder (Y/N) -</i> No <p><u>Immediate and Root Causes</u></p> <ul style="list-style-type: none"> ⦿ <i>Unsafe handling of materials</i> ⦿ <i>Design of rack</i> <p><u>Flag (highlight one):</u> Safety. Environmental / <u>Safety</u> / Ergonomic / Fire / Occup. diseases</p> <p><u>Interim Containment Action:</u></p> <ul style="list-style-type: none"> ⦿ Employee was sent to receive a medical treatment at plant medical services. ⦿ A revision the physical conditions to 100% of the containers and boxes in this work area, Cell # 20, no container damage was found. <p><u>Permanent Corrective Action:</u></p> <ul style="list-style-type: none"> ⦿ Reinforce training to employees about suitable handling of materials. ⦿ Reinforce training to employees about hand safety and risks. ⦿ Safety Awareness Campaign (Include Videos, VTV, Posters, and Awareness). ⦿ Reinforce safety revisions through inspection in areas. 	<p>Photo 1: accident / incident</p> <p>Plastic Box</p>

<p><u>Relevant EH&S Procedure/Standard</u></p> <ul style="list-style-type: none"> ⦿ <u>Standard:</u> N/A ⦿ <u>Requires Change to Standard (Y/N):</u> N/A ⦿ <u>EHS Violation or Non-Conformance (Y/N):</u> N/A 	<p><u>Key Learning Points</u></p> <ul style="list-style-type: none"> ⦿ The supervisor of Assembly must to follow up to improve the practices of handling material.

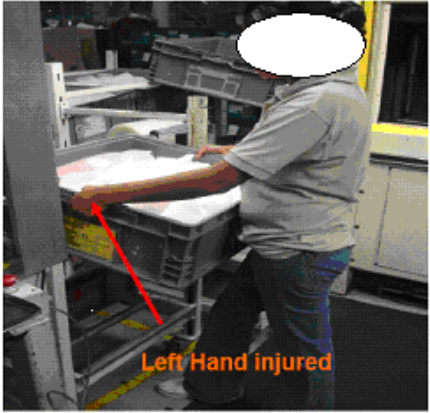
<p>Low Level Rack</p>

<p>Left Hand injured</p>

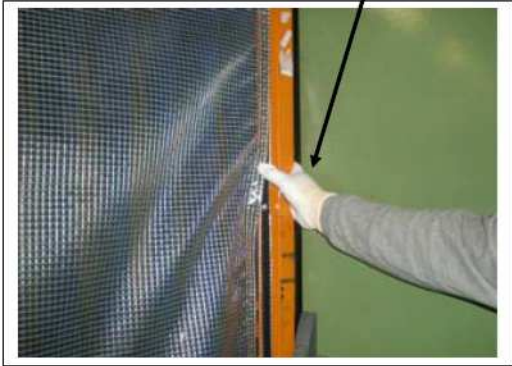
<p><u>Date & Time of Injury:</u> 06.02.2008 / 05.15 pm</p> <p><u>Incident Description:</u></p> <p>- The employee was pulling a trolley when the area became narrow because of the layout on the left and one electric box on the right. The worker didn't see the electric box and caught his second finger between the trolley and the box. The result was a cut and his second finger broken.</p> <p><u>Additional information:</u></p> <ul style="list-style-type: none"> 👉 witness (Y/N): Y 👉 supervisor informed, when: Immediately 👉 Flag: first time or repetitive disorder: 👉 Injury Type: Cut and phalange bone fissure on finger 👉 Affected Body Part: 2nd finger of his right hand 👉 Estimated lost days: 2 weeks or more <p><u>Root Cause</u></p> <p>Flag: Environmental / Safety / Ergonomic / Fire / Occup. diseases</p> <ul style="list-style-type: none"> - Unsafe manipulation from the external side. - Limited area because of layout - Narrow area for this kind of trolleys. <p><u>Interim Corrective Action:</u></p> <ul style="list-style-type: none"> - Single Point Lesson + Safety alerts about the right and wrong way for moving trolleys situated around the plant, for every worker in plant - Meeting with Production & Eng. Dep. On 13-Feb to fix the actions. - To install rubber protection on the electric box <p><u>Permanent Corrective Action:</u></p> <ul style="list-style-type: none"> - Visual Safety Alerts (80x30 mm) to display on each trolley with the right and wrong way for moving them and training about that. - Change layout. - Provide all the trolleys with a good central handling if it's possible (if not, at least, put a handle) 	<p>Photo 1: accident / incident</p>

<p><u>Relevant EH&S Standard</u></p> <ul style="list-style-type: none"> 👉 <u>Standard:</u> Move the trolleys from the handle or from the internal part. Don't move them from the external part of the structure. 👉 <u>Gap to Standard (Y/N):</u> Y 👉 <u>Safety Violation (Y/N):</u> Y 	<p><u>Key Learning Points</u></p> <ul style="list-style-type: none"> 👉 General information about the correct way of moving the trolleys. 👉 Zero tolerance for unsafe conditions and unsafe acts. 👉 Respect the layout.

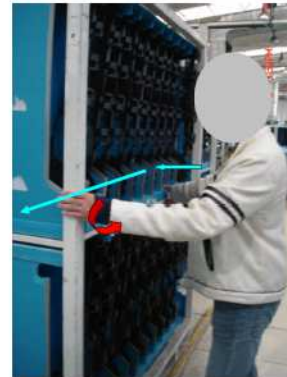
Over effort caused by handling damaged containers in the injection and painting area.

These intermediate containers have a little arm that is made for guidance. If this arm is bent because of a hit, it acts as a brake so it's more difficult to move the container when it's damaged.

Workers have to move the containers in S- 2000 1^a in this way forward up to the table where they work. In this area of injection the floor is inclined to the right in the photography so they have to control them with the left hand. If they start to move the container by force because the container is damaged it's possible that the left wrist have a bend in extension and this is a very forced movement that may cause the injury.

- Proper communication of incidents must be implemented between Supervisors and Safety in order to detect and avoid this kind of injuries that cause long term lost time cases.
- Containers must be immediately repaired to prevent new cases.

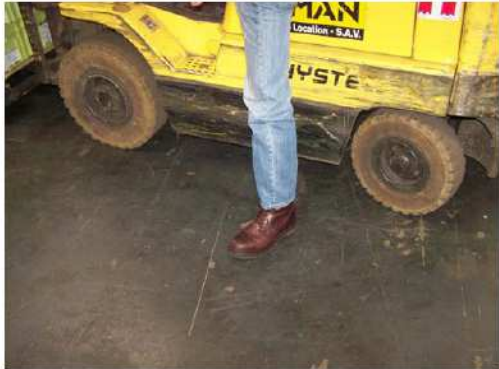
<p><u>Date & Time of Injury:</u> 05/29/08 at 4 pm</p> <p><u>Incident Description:</u></p> <p>A forklift driver was loading a truck with pallets of empty cardboard (used for the safety storage of IP plastic). She went down her forklift to move manually a cardboard that was not well placed on a pallet. When she put the left foot on the floor, she felt a strong pain on the ankle.</p> <p>The cardboard are used for the safety stocks and were used during the day because of a mould failure.</p> <p>She was wearing high shoes (especially for forklift drivers) and the floor was not wet, not slippery, not anhy granulates...</p> <p><u>Additional information:</u></p> <ul style="list-style-type: none"> ➤ witness (Y/N): - NO ➤ supervisor informed, when: - Immediately ➤ Flag: first time or repetitive disorder: ➤ Injury Type: - sprain ➤ Affected Body Part: - left ankle ➤ Estimated lost days: - 6 days <p><u>Root Cause</u></p> <p>Flag: Environmental / Safety / Ergonomic / Fire / Occup. diseases</p> <p><u>Interim Corrective Action:</u></p> <ul style="list-style-type: none"> - Communication on the accident - Checking that all forklift drivers wear high safety shoes <p><u>Permanent Corrective Action:</u></p> <ul style="list-style-type: none"> - Checking the good stability of the pallet before transport with forklift 	<p>Photo 1: Accident situation</p>

<p><u>Relevant EH&S Standard</u></p> <ul style="list-style-type: none"> ➤ <u>Standard:</u> - Packaging ➤ <u>Gap to Standard (Y/N):</u> - No ➤ <u>Safety Violation (Y/N):</u> - No 	<p><u>Key Learning Points</u></p> <ul style="list-style-type: none"> ➤ Stability of our process to use less cardboards

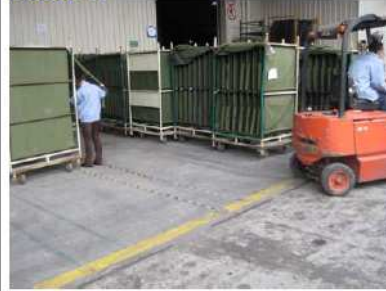
Photo 1:

1. The forklift driver was used to drive diesel forklift. It was his first time to drive a battery forklift that the brand name is Linde. He was not familiar with the performance of the battery forklift, especially the braking distance;
2. Injured employee wasn't wearing the safety shoes.

The stock controller was counting the stock when the driver backed his forklift to deliver the pallets.

1. Provide the safety training for all forklifts used by the forklift drivers;
2. Workers must wear their safety shoes during the work time as required;
3. The forklift drivers must be trained before change to use other kinds of forklifts.

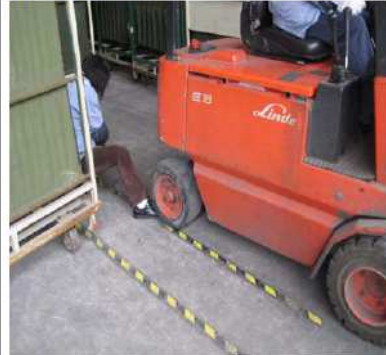
Photo 2:

The driver applied his brake quickly, but could not stop the forklift. The employee's left big toe was pressed by the forklift and injured.

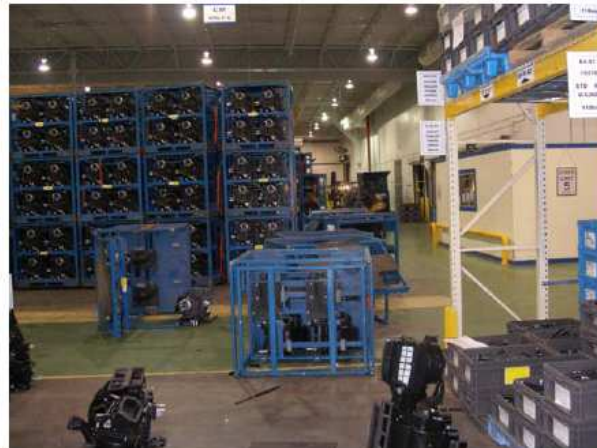
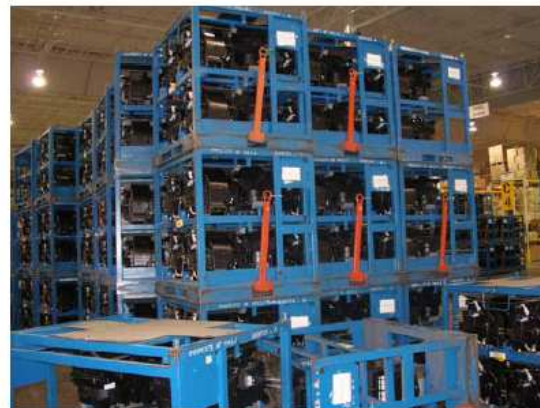
Photo:

Shipping Fork Truck Driver continued to work in a dangerous way knowing that it created an unsafe environment and could damage materials. He recognized that the fork truck's forks extended 14" beyond the rack he was moving. He also acknowledged that he witnessed the racks stacked behind the loads he was moving being lifted and rocking from the forks sticking out of the rear of the racks he was moving. He did not notify the team leader but instead continued to work while being very careful. One time, after he lifted his loaded the stack of racks behind it started to rock from being lifted as well from the forks extending out of the back of his load. The stack of racks continued to rock after he had pulled away from them until they finally fell over backwards knocking over a third stack sitting behind them. A total of five racks were knocked down.

The fork lift that he was using was not his standard lift. The lift he had been using was picked up by mistake for repair earlier that day. He had tried using a standup lift but had difficulty stacking his loads with it.

Unsafe Action by driver

Modify the current Team Member manage system used to track such occurrences and repeat occurrences by operators and drivers of dangerous equipment.

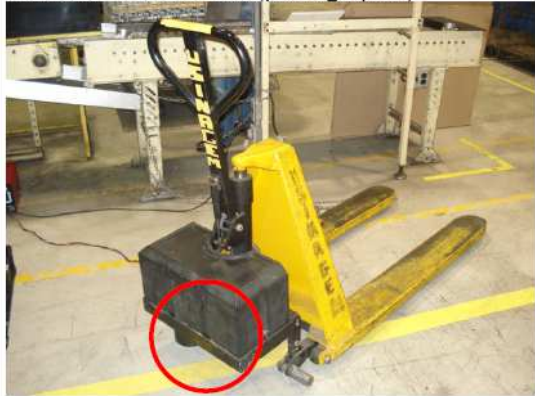
<p><u>Date & Time of Injury:</u> 15/01/2008, 13:50</p> <p><u>Incident Description:</u> <i>After closing the Kit boxes on the pallet, the employee and another employee, pulled the pallet with an electrical cart (pantographic), to the storage area. During this process the employee's right foot was hit by the cart, causing a contusion.</i></p> <p><u>Additional information:</u></p> <ul style="list-style-type: none"> ➤ Witness (Y/N): Y ➤ Supervisor informed, when: immediate ➤ Injury Type: contusion ➤ Affected Body Part: Heel ➤ Estimated lost days: 14 <p><u>Root Cause</u></p> <p><i>Flag: Environmental / Safety / Ergonomic / Fire / Occup. diseases</i></p> <p><u>Substandard Condition:</u> Inadequate Standards</p> <p><u>Interim Corrective Action:</u> <i>The employees received training about the safe behaviors and risk in this process.</i></p> <p><u>Permanent Corrective Action</u></p> <ul style="list-style-type: none"> • <i>Single Point Lesson (SPL) to all employees about the right mode to pull the cart.</i> • <i>Installation of protection below the battery area of the cart</i> 	<p><u>Photo:</u></p> <p>Photo 1: Electrical cart (pantographic)</p>

<p><u>Relevant EH&S Standard</u></p> <ul style="list-style-type: none"> ➤ <u>Standard:</u> Safety protection ➤ <u>Gap to Standard (Y/N):</u> Y ➤ <u>Safety Violation (Y/N):</u> N 	<p><u>Key Learning Points</u></p> <ul style="list-style-type: none"> ➤ <i>The employees need to receive training about the process before starting the new job.</i> ➤ <i>Updating the operation mode to pull the cart is necessary.</i> ➤ <i>All carts need protection below the battery area checked before starting work.</i>

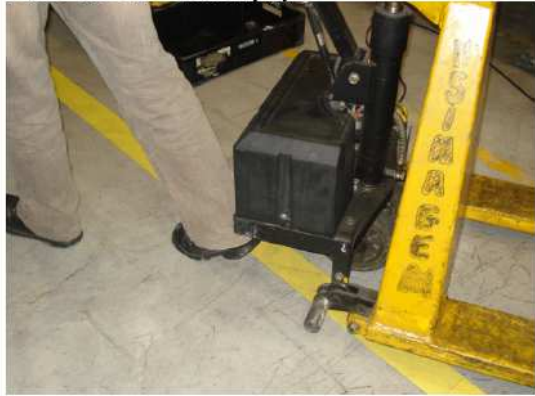
<p>Photo 2: Point of the Injury</p>

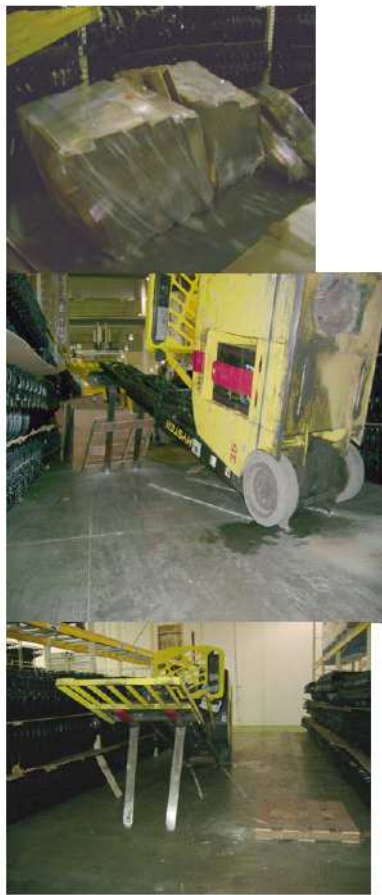
<p>Date and Time of Injury: 4/3/07 @ 1:50pm</p> <p>Problem Description Employee was removing a double stacked pallet of compressors from the top rack. He backed up as he was turning due to limited aisle space. He felt the lift rocking, stopped and tried to lower the lift, but the weight of the load took the lift over front ways.</p> <p>Interim Corrective Action 1 Area secured and outside company removed lift truck. 2 Retraining done immediately for driver whose license is valid. 3 Re-evaluate warehouse storage for pallets with heavier loads 4 Accident reviewed with all lift truck operators</p> <p>Root Cause 1 Parts were double stacked on top shelf. 2 Obstruction of warehouse overflow area where pallet was stored which caused insufficient space for lift 3 Forklift load capacity & deviation from lift truck travel procedures</p> <p>Permanent Corrective Action 1 Stacking of compressors on top rack to be single pallet only. 2 Carriers (part causing obstruction) to be moved 3 Restricted area and authorized employees only posted at all storage areas 4 Quarterly review of lift truck use 5 Daily audit for pallet hazards 6 Encourage hazard or potential hazard reporting.</p>	<p>Photo:</p>

<p><u>Key Point Summary</u></p> <ul style="list-style-type: none"> ➤ Obstructions of safe & effective lift truck operation ➤ No work instruction for heavier warehousing storage 	<p><u>Key Learning Points</u></p> <ul style="list-style-type: none"> ➤ <i>Ensure material is properly stored and material specific handling requirements are understood by relevant EE</i> ➤ <i>Areas must be kept clear of obstructions</i> ➤ <i>Design of layout and logistics of material placement</i>

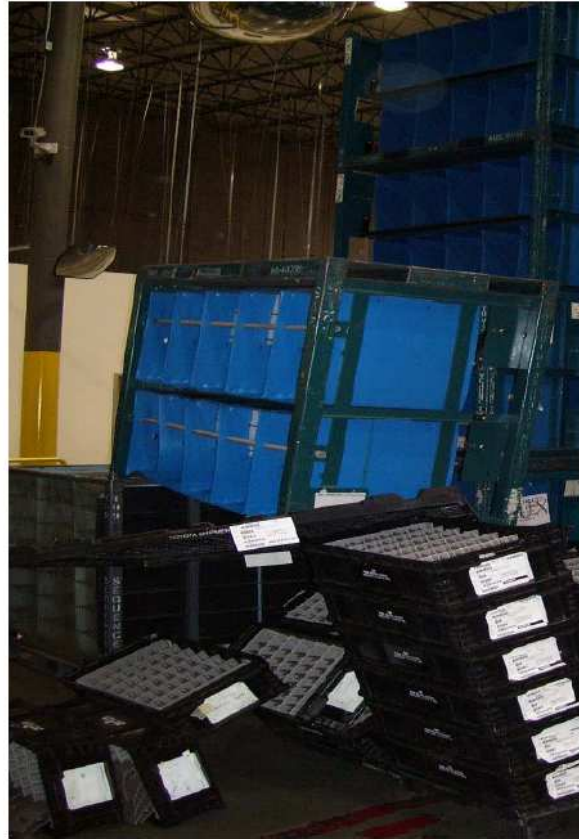
Photo:

Stacking racks too closely to each other could cause racks to lean, hang-up or stick together.

1. All racks are to be placed at a minimum of 2" apart going forward. This will prevent racks from touching and potentially sticking together.
2. Excess racks are being removed and we will store racks in 3 high.
3. Dunnage audits will be performed and documented daily to confirm dunnage is nested correctly and dunnage separated by 2" or more.
4. New warehouse layout to address this issue.

- Excess racks should be kept at a minimum
- Safety Audits should be conducted daily and review rack storage locations.
- Racks should not be stacked closely to avoid hang up
- Review stacked dunnage to be sure no dunnage is stacked where it could fall into the workspace of an operator.

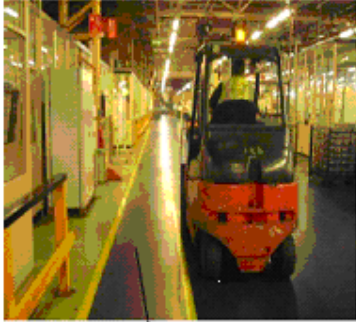
<p>Date: 14/08/2007 Time: 09:00hrs</p> <p>Estimated lost time: 5 days Expected return date: 21/08/2007</p> <p>Description of incident:</p> <p>Injured employee is a Supervisor and had just instructed a fork lift truck driver to perform some work in a different area of the building. The fork lift was parked on the main aisle close to pedestrian walkway. Supervisor was standing on pedestrian walkway as he gave FLT driver instructions. FLT driver acknowledged instruction and started to move off, effecting a u-turn manoeuvre. As he did so, the rear nearside wheel of the fork lift ran over the Supervisors right foot.</p> <p>Injury Type:</p> <p>Severe bruising to right foot.</p> <p>Actions Taken:</p> <ul style="list-style-type: none"> • FLT driver removed from driving duties until outcome of investigation finalized. • FLT removed from service for inspection – All OK (15/08/07). • Both individuals reminded of need to ensure adequate separation of vehicles and pedestrians. 	<p>Photos:</p>

<p>Injured employee stood here</p>

<p><u>Key Point Summary</u></p> <ul style="list-style-type: none"> ➡ FLT driver failed to consider extended swinging arc of truck, as he performed the u-turn. ➡ Failure by both individuals to effectively implement 2 foot rule. 	<p><u>Key Learning Points</u></p> <ul style="list-style-type: none"> ➡ Re-communicate safety alert regarding 2 foot rule, to all employees. ➡ Conduct refresher training for fork lift operator.

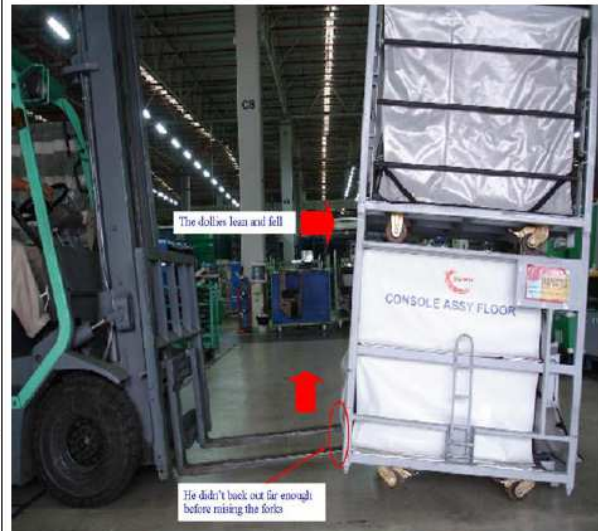
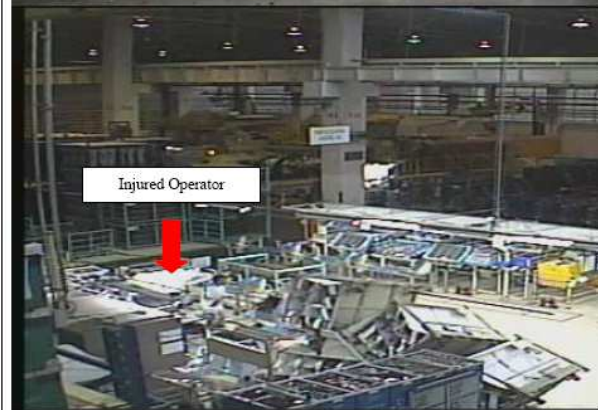
Photos:

On September 20, 2007 the MP&L operator drove forklift to serve 3 stack Nissan dolly from substrate area to Nissan assembly line. When backing up to be able to set down the dolly, his forks did not clear the bottom dolly and he lifted his forks up. This caused the racks to fall forward and the top rack fell and landed on another single dolly before striking the operator.

- The operator attempted to unstuck dollies inside the assembly area.
- The operator did not back out far enough before raising forks.
- Changed all racks to be stacked only 2 high.
- All racks are served to the assembly lines by the operator pushing the dolly into the assembly area.

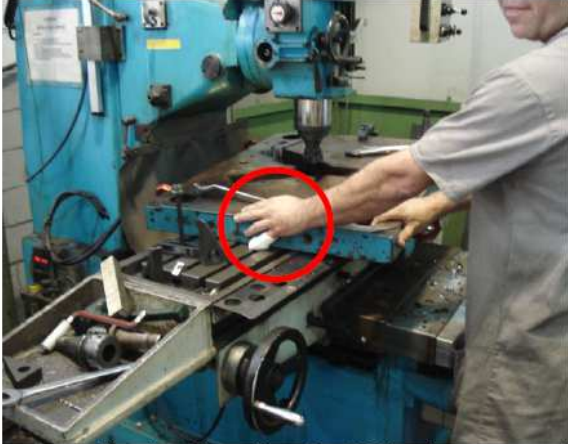
<p>The chock has slipped and fallen down (illustration photo)</p>

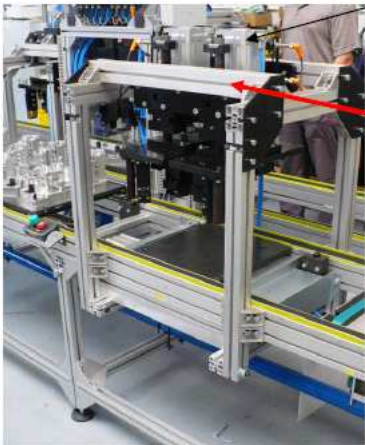
<p>Date & time of incident : 06.11.2009 11:00 a.m.</p>	<p>Photo 1 :</p>
<p>Incident description :</p> <p>The operator of Tool Room, BT 9510, was working on newly developed assembly line including their testing, setting in order to verify all functions of this machinery. The operator paused for a moment at the pressing station (photo 1) with two pressing pistons. He put his right hand on the frame in a moment, when both pistons were in top dead centre. All fingers were put inside the space of pressing tool. The assy line was runing in self-acting cycle, when both pistons were activated to make movement to bottom dead centre. This movement caused total amputation of right little finger.</p> <p>Additional information :</p> <ul style="list-style-type: none"> ➤ Witness (A/N) : Y ➤ Supervisor informed (Y/N),when : Y, 11:03 ➤ Firts time occurrence (Y/N): : Y ➤ Injury type : amputation ➤ Affected body part : little finger (right hand) ➤ Lost days : - 60 days <p>Root cause :</p> <p>Flag : <i>Environmental / <u>Safety</u> / Ergonomics / Fire / Occup.diseases</i></p> <ul style="list-style-type: none"> - improper working position - inadequate communication with all other operators <p>Interim Corrective Action :</p> <ul style="list-style-type: none"> - immediate interruption of all operating procesess - Safety Stand Down in whole Autopal plants - all shifts - transport of injured worker to hospital <p>Permanent Corrective Action :</p> <ul style="list-style-type: none"> - verification of all working instructions, especially for development, production and testing of new machinery - verification of ECPL principle - prepare proper layout including safety guarding of the working space to protect all other employees - clearly nominate responsible team leader for all production, testing and setting procesess, ECPL , cleanliness 	<p>station with pressing tools operated by 2 pneumatic pistons</p>

<p>alum. frame of pressing tool</p> <p>Photo 2 :</p>

<p>Relevant EH&S Standard</p> <ul style="list-style-type: none"> ➤ Standard : - ➤ Gap to Standard (Y/N) : - A ➤ Safety Violation (Y/N) - A 	<p>Key Learning Points</p> <ul style="list-style-type: none"> ➤ - prevent the hand contact against moving elements on the machine by proper safety guards ➤ - ensure all procesess of production, assembling and testing by adequate working instruction ➤ - verify any intended action on the machine, which would be different to standard procedure

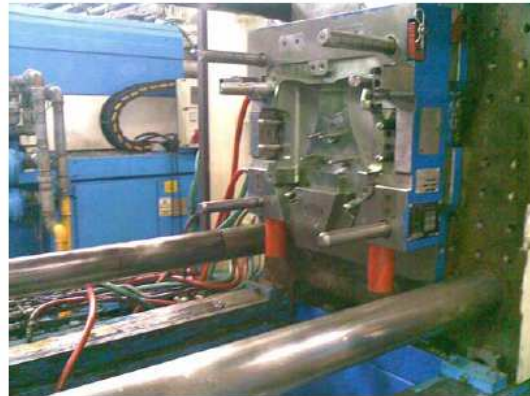
A mould operator was taking off one half mould from the machine with a crane to transport it to maintenance area for repair.

- Unsafe act.- Placing hand between a moving suspended load and fixed point.

Photo 2: View of mould from other side

- Everybody must respect safety rules, always. Do not let years of experience create over confidence **Zero tolerance.**
- Mould design including housing for extractors is safer (this design allows solving this kind of technical issues in-situ, without removing half-mould from Machine).
- When possible suspension points should be provided in designs for balanced lifting of whole and half moulds
- Standardized procedures should be developed for lifting unbalanced loads or when side loading is required (Removing half-mould from machine is a delicate operation needing more attention, specially if there are not specific connection points for a balanced lifting)

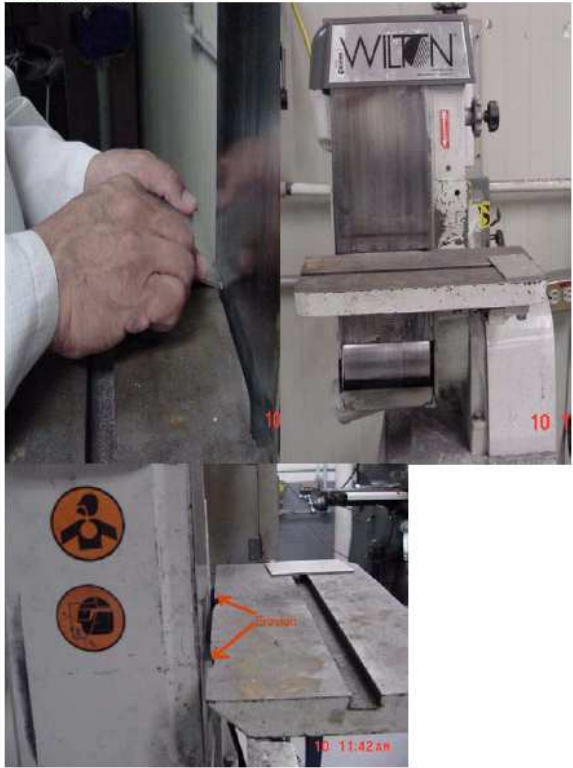
<p>Date and Time of Injury: Sep 10,2007 at 11:30 AM</p> <p>Problem Description: Employee was working in the sander machine with an aluminium piece, (1/4" x 2" x4"). The aluminium piece was jammed between the band sander and the support table and at this moment the aluminium piece caught and hit the right index finger.</p> <p>The investigation identified that the support table has erosion points and it causes the jammed problem.</p> <p>The employee suffered a cut and contusion.</p> <p>Interim Corrective Action:</p> <ul style="list-style-type: none"> • The employee was moved to plant medical services and the employee received medical treatment. • The employee was moved to external medical services • The plant limited the access to the incident area and started the incident investigation • The plant stopped the activities in machine <p>Root Cause:</p> <ul style="list-style-type: none"> • Erosion in the support table <p>Permanent Corrective Action:</p> <ul style="list-style-type: none"> • Change the support table • The employees will receive a refresh safety inspections training 	<p>Photo: Sander Machine</p>

<p>Key Point Summary Erosion in support table Similar risks exist with grinding wheels</p>	<p>Key Learning Points</p> <ul style="list-style-type: none"> ⇒ Reinforce the safety inspections all employees ⇒ To be proactive starting an exhausting JSA review in the maintenance area and trying to eliminate or control the safety risk

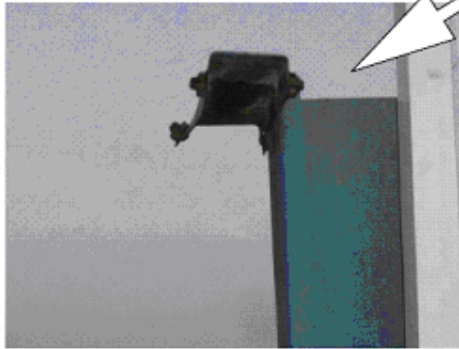
Cause: The situation (rental warehouse) have a inadequate maintenance of periferical wall and door. Inadequate design of the door (no robust).

Description of Incident: During the action to close the door (external), when finish the work labors, the door us fall down because the upper support was degraded by inadequate maintenance.

- Inadequate maintenance of doors and wall installation.
- Inadequate design of the external door.
- Standardize and control (contract) all EH&S requirements in the rental warehouse or building.

- Review all the wall and doors around the plant and fix all damage installation.
- Re-design of the system to guided the doors with more robust design.
- Review and update the maintenance controls of installation.

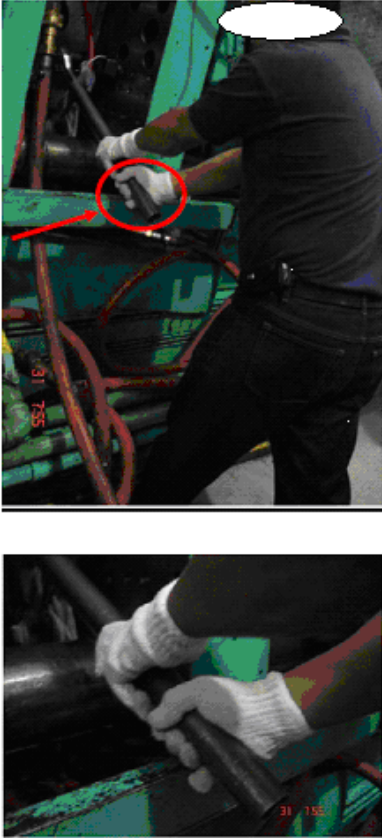
<p>Date and Time of Injury: JULY 26, 2007</p> <p>Problem Description WHILE ADJUSTING SCREWS IN A MOLD, THE EMPLOYEE APPLIED PRESSURE TO THE TOOL, HE STRUCK HIS HAND CAUSING A CONTUSION IN HIS RIGHT FINGER ((BETWEEN THE BASE OF THE DOOR AND THE TOOL EXTENSION)).</p> <p>Interim Corrective Action</p> <ul style="list-style-type: none"> • THE ACTIVITIES IN THE AREA STOPPED • MEDICAL ATTENTION OFFERS HIM (FIRST AID) • INVESTIGATION OF THE EVENT IS MADE • FEEDBACK TO THE TECHNICAL PERSONNEL OF SIMILAR OPERATION OF MOLD AREA (PLANT 1) <p>Root Cause</p> <ul style="list-style-type: none"> • A WORK PROCEDURE DOES NOT EXIST • INADEQUATE POSITION OF WORK <p>Permanent Corrective Action</p> <ul style="list-style-type: none"> • TO ELABORATE JOB SAFETY ANALYSIS • TO MAKE AN INVENTORY OF THE AMOUNT OF SCREWS AND TOOLS THAT ARE REQUIRED FOR THE OPERATIONS OF CHANGE OF MOLDS • FEEDBACK TO THE TECHNICAL PERSONNEL OF SIMILAR OPERATION OF MOLD AREA IN ALL AREAS WHERE EXIST THIS ACTIVITY (PLANT 1&2) 	<p>Photo (s):</p>

<p><u>Key Point Summary</u></p> <p>➤ TO CHANGE SCREWS HEAD SOCKET</p>	<p><u>Key Learning Points</u></p> <p>➤ REINFORCE THE BEST PRACTICES FOR CONDUCTING THESE ACTIVITIES</p>

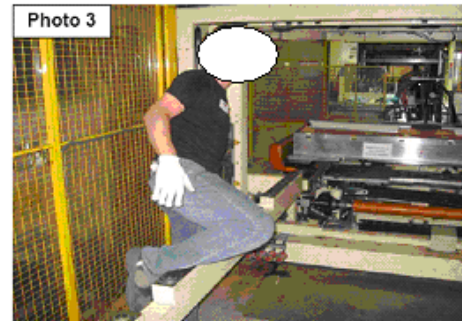
Photo 3

During the tool change at a covering machine (Photo 1 und 2) Mr. [redacted] wanted to rise over the tool roller conveyer (Photo 3), in order to push the tool with the change car from the machine, he remained hanging with his foot and fell on his right elbow.

- ⇒ Instruction by supervisor again!
- ⇒

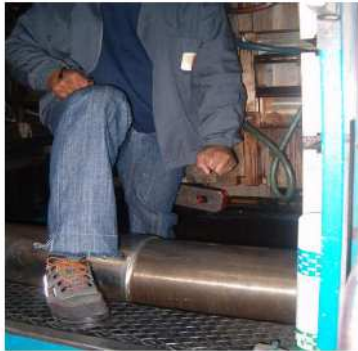
<p><u>Date & Time of Injury:</u> 27 feb 2008 11:30 am</p> <p><u>Incident Description:</u></p> <p>- A maintenance worker rested his right foot on the upper platform in order to go out of the machine. When he propelled himself, his right foot slipped and he twisted his right ankle.</p> <p><u>Additional information:</u></p> <ul style="list-style-type: none"> ➤ witness (Y/N): - y ➤ supervisor informed, when: -at the moment ➤ Flag: first time ➤ Injury Type: sprain in right ankle ➤ Affected Body Part: - right ankle ➤ Estimated lost days: - 10 days <p><u>Root Cause</u></p> <p>Flag: Safety and Ergonomic</p> <p>The platform is under an important height and worker need an effort to go out of it.</p> <p><u>Interim Corrective Action:</u></p> <p>-</p> <p><u>Permanent Corrective Action:</u></p> <ul style="list-style-type: none"> - Place a portable stair in order to come in and out of the platform. - Place an interior handle to reduce the needed strength to push up. 	<p>Photo 1: accident / incident</p>

<p><u>Relevant EH&S Standard</u></p> <ul style="list-style-type: none"> ➤ <u>Standard:</u> - ➤ <u>Gap to Standard (Y/N):</u> - ➤ <u>Safety Violation (Y/N):</u> - 	<p><u>Key Learning Points</u></p> <ul style="list-style-type: none"> ➤ - A training to every worker related to maintenance explaining what happened. ➤ - Revision of the risk assessment.

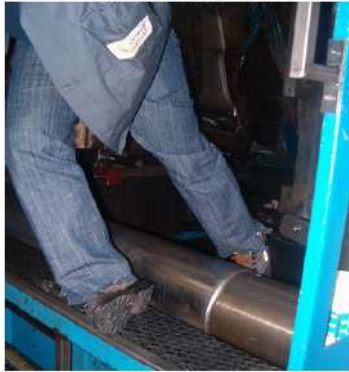
<p>Photo 2: place of incident / work environment or corrective action</p>

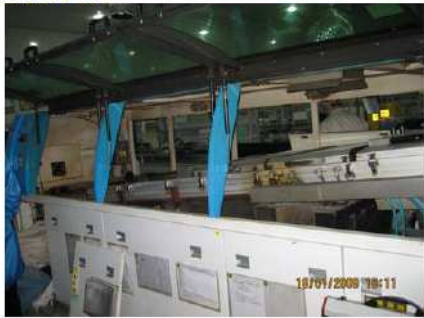
<p><u>Date & Time of Incident:</u> 2009-01-18 14:15 PM</p> <p><u>DRS Incident number:</u></p> <p><u>Incident Description:</u> In the preheat zone of wave solder machine in NO 5 Drop, a flash occurred and a fire ensued one minute later. The bottom of vent-pipe was burnt. The machine operators cut the power and put out the fire immediately. No people were injured.</p> <p><u>Immediate and Root Cause</u></p> <ul style="list-style-type: none"> •Concentration of flammable gas accorded with explosion limits •The distance between preheat and Flux spread is too close <p><u>Interim Containment Action:</u></p> <ul style="list-style-type: none"> •Check the exhaust fans' operation before work. And check them once every two hours. •Clean the filter in flux tank once every four hours. Clean the entire flux tank. •Cancel the first preheat zone and keep enough hot insulation distance. <p><u>Permanent Corrective Action:</u></p> <ul style="list-style-type: none"> •Check the exhaust every month. The flux must be more than 10 M³/min •Add the linkage system of exhaust fans and machines. •Clean the wave solder machine enough and renew "5S" system •Update the line which preheat zone is insulated from Flux spread zone 	<p>Photo 1:</p>

<p><u>Relevant EH&S Procedure/Standard</u></p> <ul style="list-style-type: none"> ➤ <u>Standard:</u> ➤ <u>Requires Change to Standard (Y/N):</u> ➤ <u>EHS Violation or Non-Conformance (Y/N):</u> 	<p><u>Key Learning Points</u></p> <p><i>Permanent Corrective Actions will be extended to other lines</i></p>

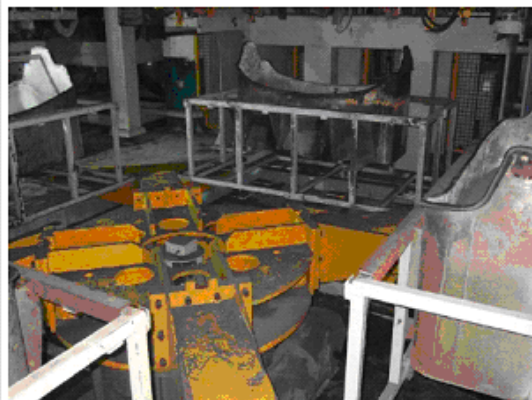
Photo 1:

An accident occurred at about 22:40 on September 26. Mr. ☐ (Male, 27 years old), the operator of No.4 slush machine group IP area of Cockpit Plant slipped to the pit from the rotary table when he was standing on the rotary table to clean up the plastic bag on the bucket. He knocked against the bracket and his 10th rib on the left side was broken.

- Improve the risk identification for the maintenance operation of all the equipments.
